# UST CLOSURE INSPECTION CHECKLIST

Inspector's Name K. GageDate 12-7-92

Facility/Site Name: Southern Seeding ServiceCity/Town: GreensboroCounty: GuilfordOwner: Southern Seeding Service

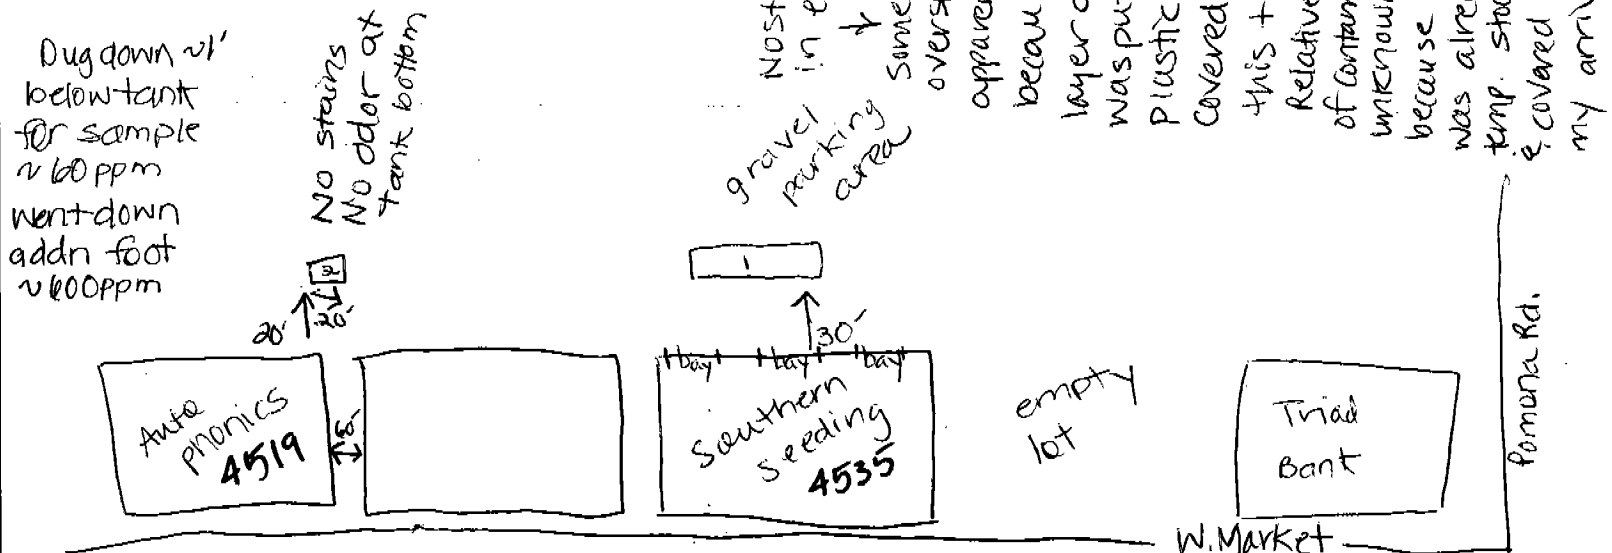
DIAGRAM OF SITE INVESTIGATION AT UST CLOSURE

Diagram should include physical structures such as roads, buildings, etc.; former location of USTs, pumps, product lines; soil sampling locations; and location of excavated soil.
